# LOCATION FACTOR AND ITS IMPACT ON ANTENNAE SAFETY WITH REFERENCE TO DIRECT LIGHTNING STRIKES.

Z. A. Hartono & I. Robiah

Lightning Research Sdn. Bhd.  
457 Jalan B11, Taman Melawati,  
53100 Kuala Lumpur, Malaysia  
e-mail: [hartono@pc.jaring.my](mailto:hartono@pc.jaring.my)

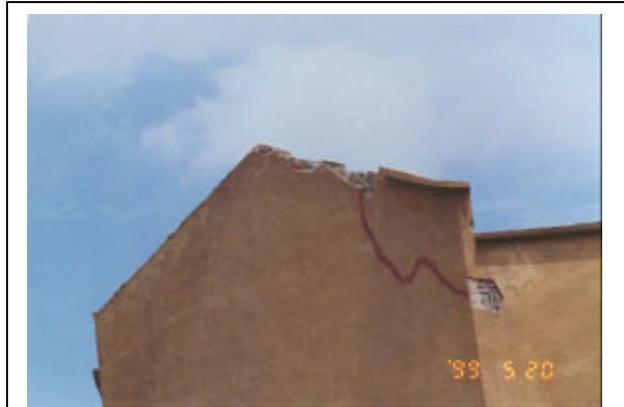
Fig. 1: A lightning damaged façade of a 10m high shop. Several other damaged façades could be found on nearby buildings of similar height.

For low buildings, such as homes and shops, the PSPs are commonly found on the highest parts of the buildings such as the top of the roofs and facades. It has been observed that the units at the far ends of a row of connected buildings of the same height have a higher probability of being struck by lightning [Fig. 1].

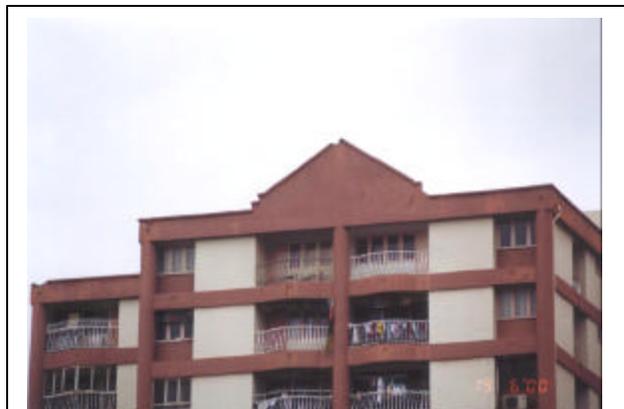
Fig.2: A highrise apartment building showing two typical lightning damaged locations (top of façade and corner on far left).

For tall buildings (i.e. above 50m in height), the PSPs are to be found mainly on the protruding corners on the flat or slanted roofs instead of the highest points. It has also been observed that the incidence of multiple strikes on the exact same location is more commonly found in tall buildings [Fig. 2].

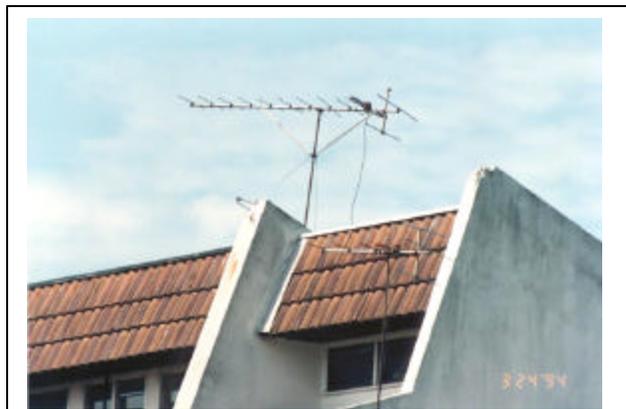
Fig.5: A TV antenna installed close to a PSP, with an already damaged PSP nearby.

- 1) At or near to corners of rooftops of tall buildings [Fig. 3]
- 2) At or near to apex of facades [Fig. 4]
- 3) At or near to the protruding features of sloping roofs [Fig. 5]

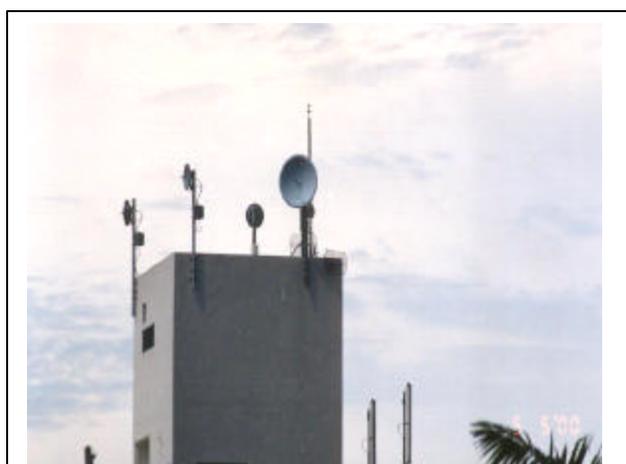
Fig. 6: Several microwave antennae installed on a roof that has been installed with a proprietary lightning air terminal.

With more businesses and service providers relying on private communication networks, the use of satellite receiving and microwave antennae has been on the increase. These antennae face the same problem since some of them have been installed at or near the PSPs. [Fig. 6]

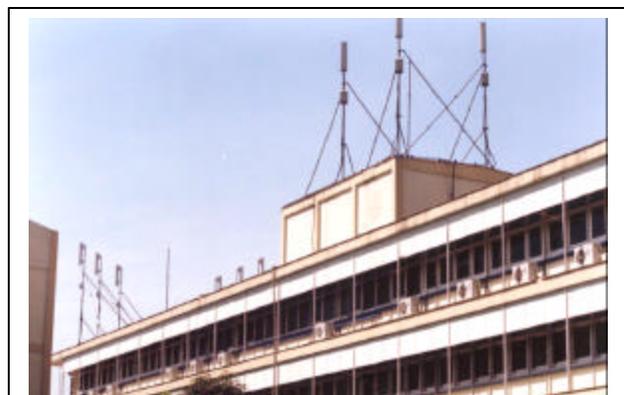
Fig. 7: Cellular phone system antennae installed on and close to the PSP with two proprietary air terminals installed nearby.

By far, the installation of the cellular telephone antennae face the biggest risk since the majority of these installations are being installed right on the PSPs [Fig. 7]. This shows that in-depth understanding of the lightning strike behaviour are required by those who supervise or install the cellular systems to avoid making such errors.

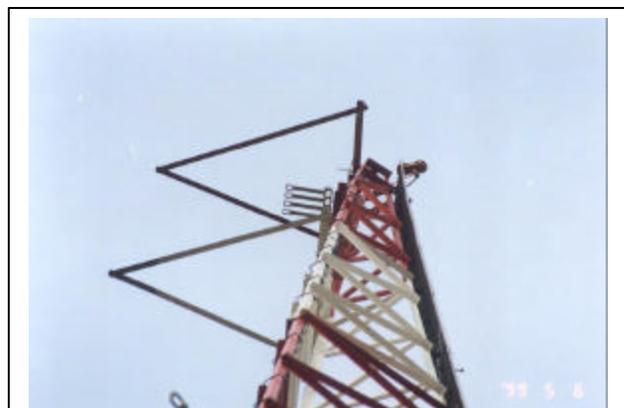
Fig.8: A radio system antennae installed near the top of the mast and protected between two simple triangular shaped horizontal air terminals.

These antennae can be effectively protected by installing slanted or horizontal air terminals above them in order to intercept the lightning discharge that approach the mast from a low trajectory. [13] This method has been applied with satisfactory results so far. [Fig. 8]

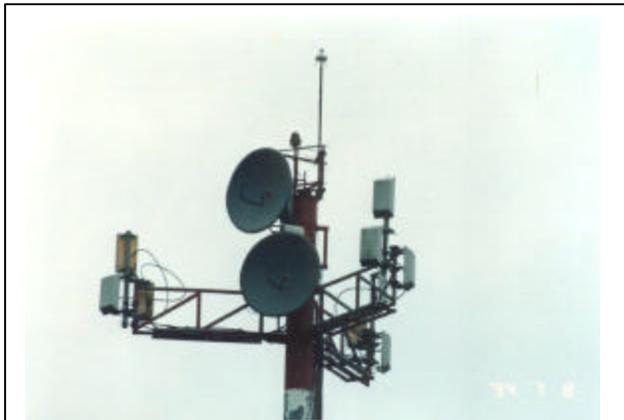
Fig. 9: Cellular phone system antennae installed on horizontal extensions. The antennae face a higher risk of being struck by lightning in this case.

In some cases, the cellular antennae are mounted on horizontal metal extensions from the mast that emanate at or below the top. [Fig. 9] This practice may significantly increase their risk of being struck by lightning since the antennae is located beyond the safety zone afforded by the mast.

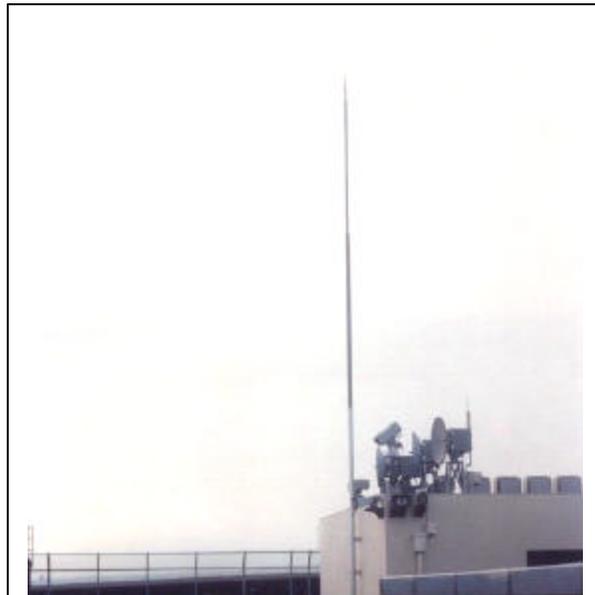
Fig. 10: A single extended Franklin rod used to protect a cluster of antennae on the roof of Narita Airport. The conventional lightning air terminal is widely used in Japan.

The following figures provide some examples on the use of the extended Franklin rods in Japan. [Figs. 10, 11 and 12].

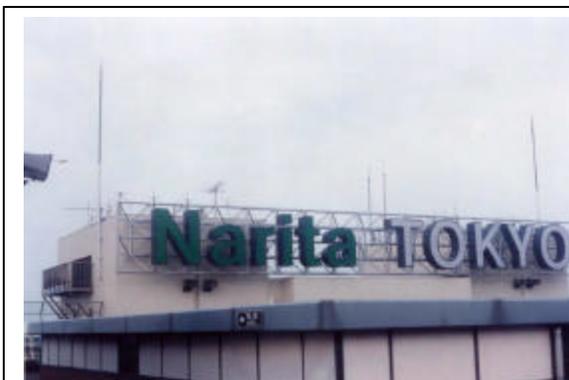
Fig. 11: Two extended Franklin rods being used to provide a corridor of protection for a number of antennae installed near and between them.

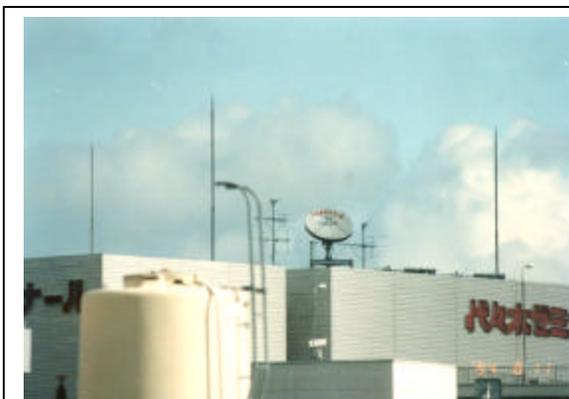
Fig. 12: Three extended Franklin rods being used to provide a wide area of protection for a large satellite antenna and several other antennae.
