## THE APPLICABILITY OF LIGHTNING ELIMINATION DEVICES TO SUBSTATIONS AND POWER LINES

Abdul M. Mousa, Fellow, IEEE  
British Columbia Hydro  
Burnaby, British Columbia, Canada V3N 4X8

**Abstract** Unlike the Franklin lightning rod which achieves protection by providing a sacrificial point for the termination of lightning flashes, special devices employing the point-discharge phenomenon have been marketed since the early 1970's with the objective of eliminating lightning strikes. The application of those devices has been mostly limited to communication towers and other tall structures, with the manufacturers claiming success and the scientific community expressing strong scepticism. In recent years, the manufacturers have been attempting to sell those devices to electric utilities for use in substations and on power lines. This paper presents a new theory which reconciles the apparent success of such devices in minimizing/eliminating lightning damage to many tall towers with the established scientific position regarding their inability to eliminate lightning. This paper also shows that lightning elimination devices would not benefit power lines nor substations.

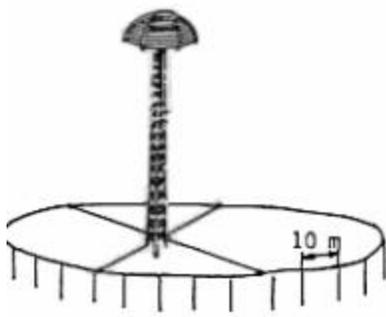
A) Umbrella dissipater installation

1. The charge dissipater types presently used by Manufacturer "A": Figs. 1 A and 113 show the umbrella dissipater which is used for towers up to 100 m in height. As an example of the related dimensions, **the unit which was used on a 30.5 m (100 ft) tower at the NASA satellite tracking station on Merritt Island, Florida, was about 6 m in diameter** with about 300 m of barbed wire wrapped spirally around the frame of the umbrella (Bent et al., [4]). The barbed wire typically has four points spaced every 7 cm along the wire; the four points are separated by approximately 900 around the wire and are 2 cm long. Fig. 1C shows a ball dissipater which is being promoted as a "hybrid terminal which will prevent most lightning strokes and collect all others". Fig. 1D shows the barbed wire conical array which is used for the taller towers. **This is larger at the base than at the top by a factor of up to 6:1.** The conic array can be used to protect a ground area rather than a tall structure by installing a dedicated pole in the middle of the subject area and attaching the barbed guy wires to it. For power

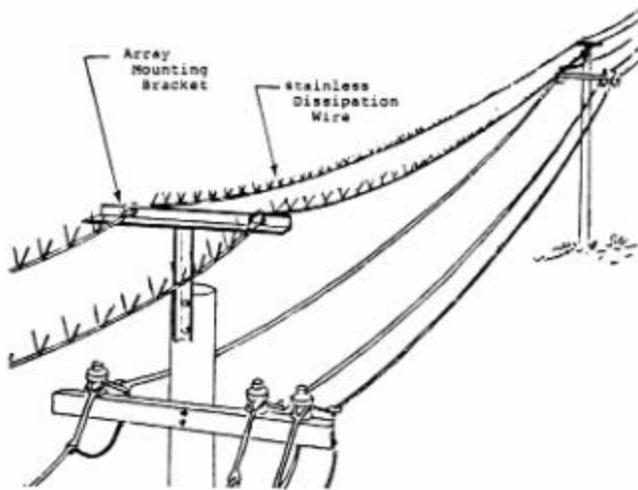
E) Barbed shield wires

lines, the traditional shield wires are replaced by barbed wires as shown in Fig. 1 E. In addition to the above configurations, Manufacturer "A" earlier used rigid metallic panels with protruding sharp points (panel dissipaters) which are similar to what one might expect in a "fakir's bed of nails". The material is conducting and typically has 4 cm high sharp points separated by 6 cm (Bentet el [4]).

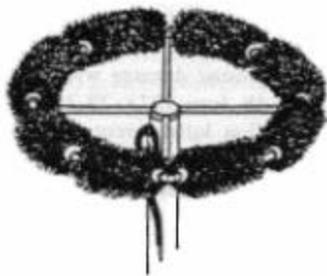
F) Doughnut dissipater

2. Fig. 1F shows a doughnut dissipater built by Manufacturer "B". The circular core is a solid stainless steel wire and ranges **from 0.75 m (30") to 3.6 m (12 ft) in diameter**. Extending from the core are hundreds of stainless steel needles ranging in length from 7.5 to 35 cm (3 to 14") (Bell [3]).

In addition to the above, a fourth manufacturer builds a skinny version of the doughnut dissipater which is shown in Fig. 1F, and a fifth manufacturer markets a panel dissipater (fakir's bed of nails) similar to the device earlier used by manufacturer "A" (Drabkin and Carpenter, [10]).

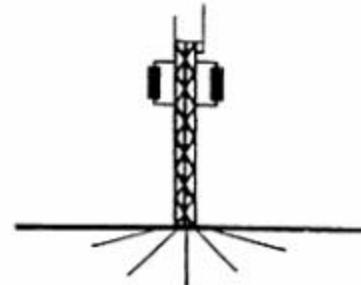
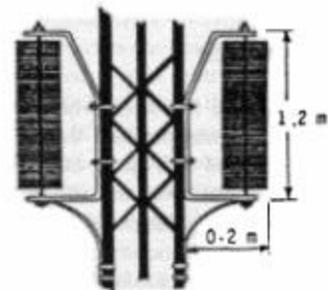
G) Cylindrical dissipater installation

H) Close-up of cylindrical dissipaters

3. Figs. 1G, 1H and 1I show a cylindrical dissipater system built by Manufacturer "C". This consists of three units installed at or near the top of the structure, spaced 1200 from each other, and each having about 14,000 points.

It should be noted here that the manufacturers of charge dissipaters usually require that extensive grounding be also installed. For the cylindrical array system of Manufacturer "C", a typical configuration would be a ring made up of #210 stranded copper wire located outside the footings of the tower by a distance of about 1 ft (0.3 m), anchored by six 3/4"x 10 ft (19mm x 3.05 m) copper-clad ground rods, and **connected to an 8-arm radial counterpoise** made up of #10 solid copper wire **and having a length equal to about 1/3 of the total height of the tower**. For the dissipation arrays of Manufacturer "A", the typical grounding consists of a **copper ring which** encircles the protected site, and is enforced with 1 m long **ground rods located at 10 m intervals around the circumference of the ring**. For high resistivity soils, Manufacturer "A" promote the use of salt-leaching rods which it manufactures. Such a rod consists of two 3" (76 mm) hollow copper tubes, one is 3 ft (0.9 m) long and the other is 6 ft (1.8 m) long, forming a T-shape and filled with a chemical which leaches in the ground to reduce soil resistivity in the surrounding area. According to a testimony letter from Lafayette Utilities System dated 22 April 1991, those chemical rods were installed at each of the substations where the charge dissipaters of Manufacturer "A" were installed. In addition to the grounding, some charge dissipater manufacturers, especially Manufacturer "A", also require that surge arresters be added.

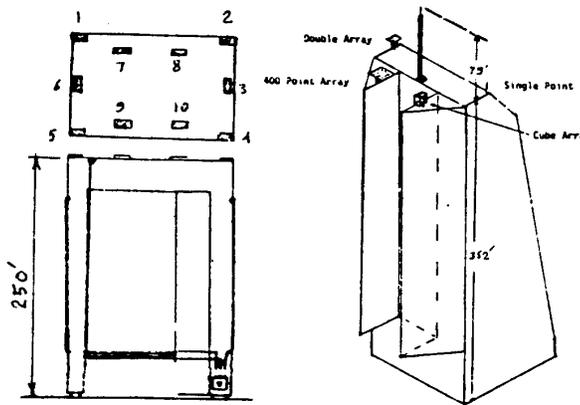
Fig 2. Configuration of the dissipation arrays used on the Mobile Service Structures at Kennedy Space Center [11].

2. According to [11], the shape of all the dissipation arrays used on three structures at Kennedy Space Center which are discussed in Section 2.1(1) was that of fiat panel arrays (fakir’s bed of nails). Fig. 2 shows two of those structures as examples. Such dissipaters do not change the effective configuration of the structure and hence cannot have an impact on the occurrence of upward flashes. Further, the overall heights of the structures shown in Fig. 2 are 427 ft (130.2 m) and 250 ft (76.2 m), respectively. With the altitude of the subject ocean-side installation being only a few meters, the effective heights of both structures were less than half the 300 in critical value. Hence, upward flashes did not occur in the first place. **The combination of the above factors made the above sites the perfect place to demonstrate the fallacy of the underlying theory, and that is exactly what happened!**
